## **SEISMIC VULNERABILITY ASSESSMENT OF SLENDER MASONRY STRUCTURES**

Thesis submitted to the University of Aveiro to fulfill the requirements to obtain the degree of Doctor of Philosophy in Civil Engineering, under the scientific supervision of Dr. Humberto Salazar Amorim Varum, Associate Professor with Habilitation, Department of Civil Engineering, University of Aveiro and co-guidance of Dr. Romeu da Silva Vicente, Assistant Professor, Department of Civil Engineering, University of Aveiro and Dr. Aníbal Guimarães Costa, Full Professor, Department of Civil Engineering, University of Aveiro.

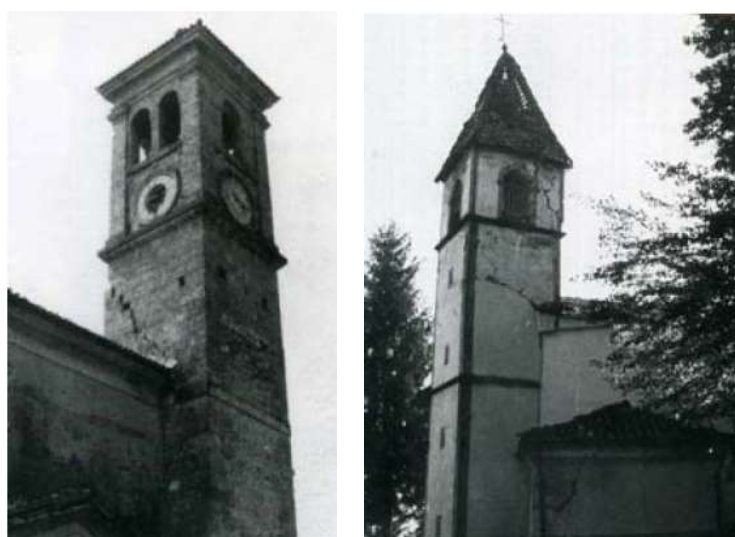
**Figure 4.9:** Earthquake damage at the bond provided by the adjacent structure [21]
